AGA Door Lever Repair Kit

2008-2015 C-Class (W204 Chassis)

Part #: AGA-MB-DLK-204

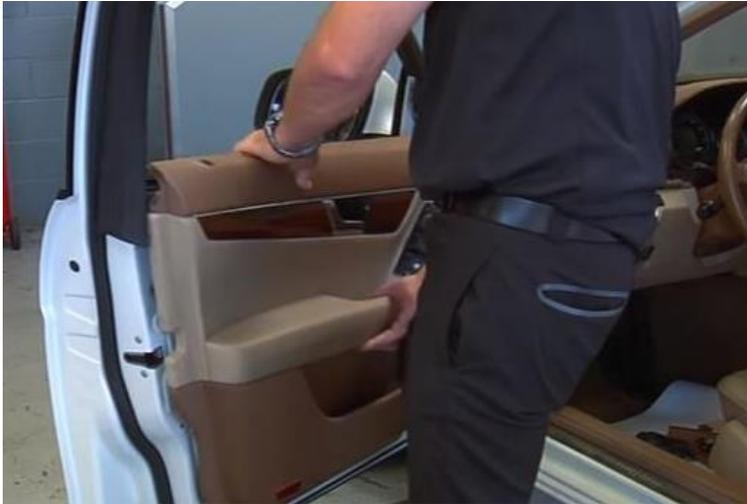
1: Remove door panel. This can vary from vehicle year and model. Refer to M/B manual, All Data, or a similar information source for details on the exact removal procedure. Be careful not to pull hard when removing the panel to avoid damaging any wire connections.

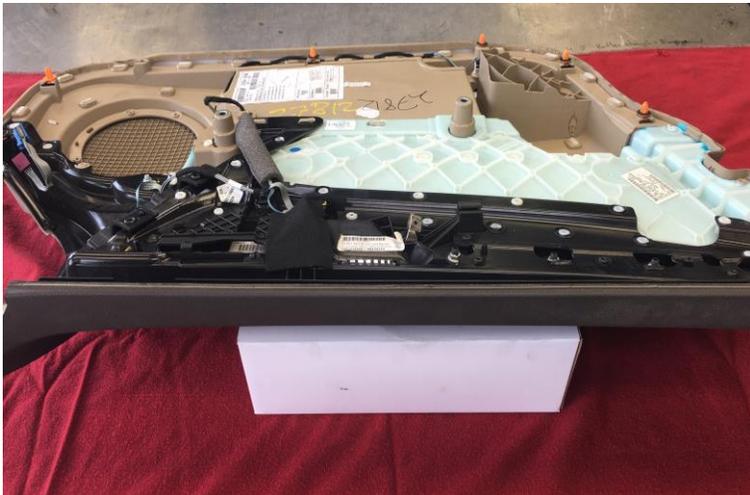
2: We recommend placing the removed door panel on a clean surface with the inside facing up and the top of the panel toward yourself. Place a clean support such as a box beneath the lever. This will ensure that the lever will be in a closed/retracted position while doing the repair.

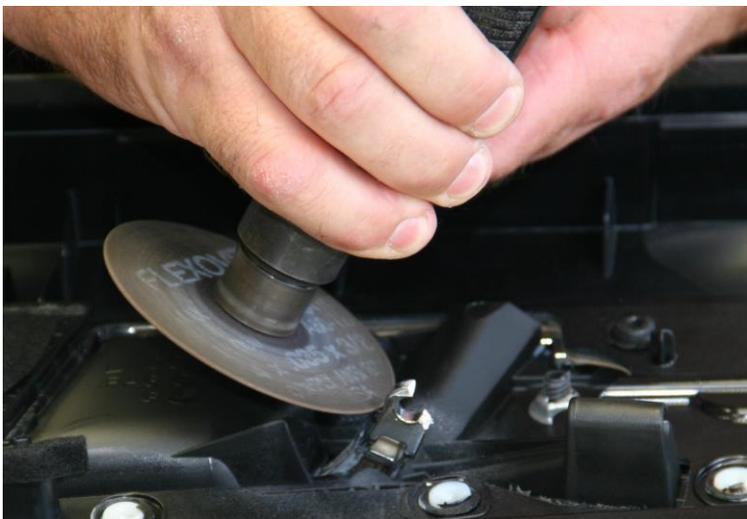
3: Cut off remaining broken tab with a cut-off wheel or similar device.

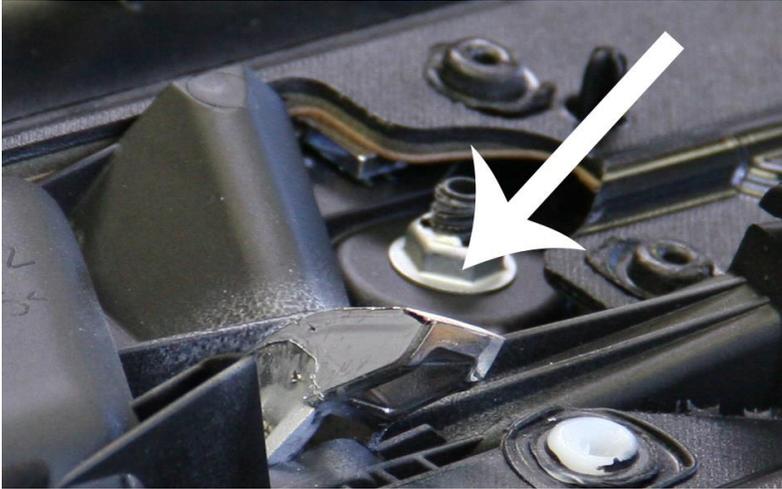
4: Grind or sand tab until it looks like this.

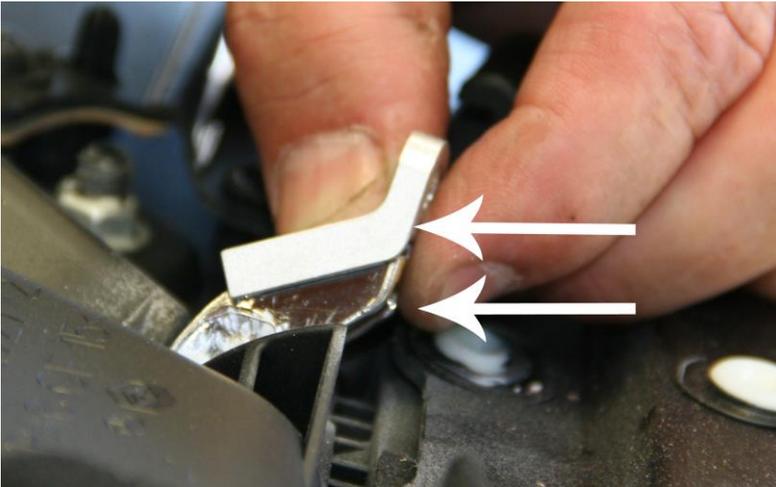
5: Place new aluminum bracket on lever. Make sure the bottom of the new aluminum bracket and the cut plastic lever is aligned. **(see arrows in picture)**

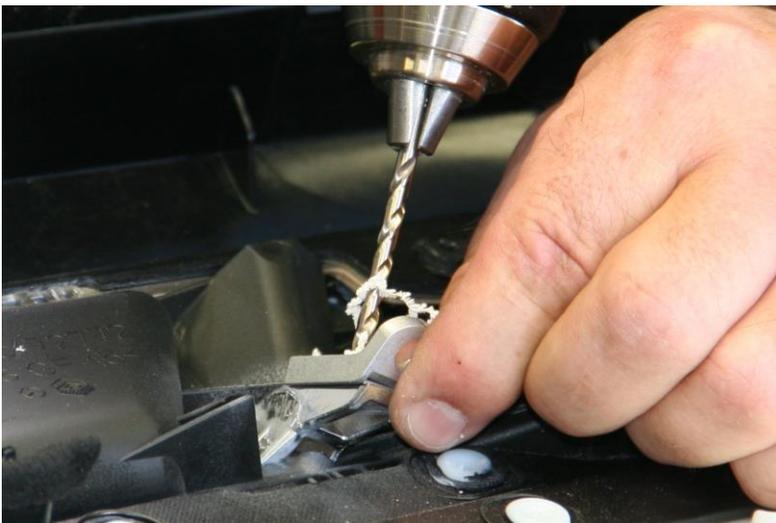
6: Use the aluminum bracket as shown in the previous picture as a drill guide. Drill a hole in the plastic lever using the supplied #28 drill.

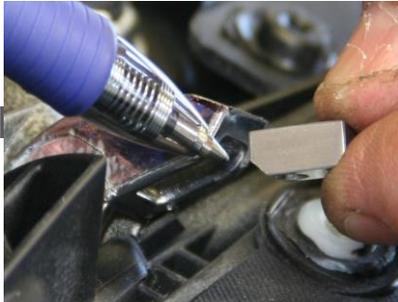
Picture A

7: As shown in Picture A, the hole must be installed toward the top of the door panel (closest to you) and the chamfered corner away from the lever. As show in Picture B, place the threaded block in the bottom groove of the plastic lever.

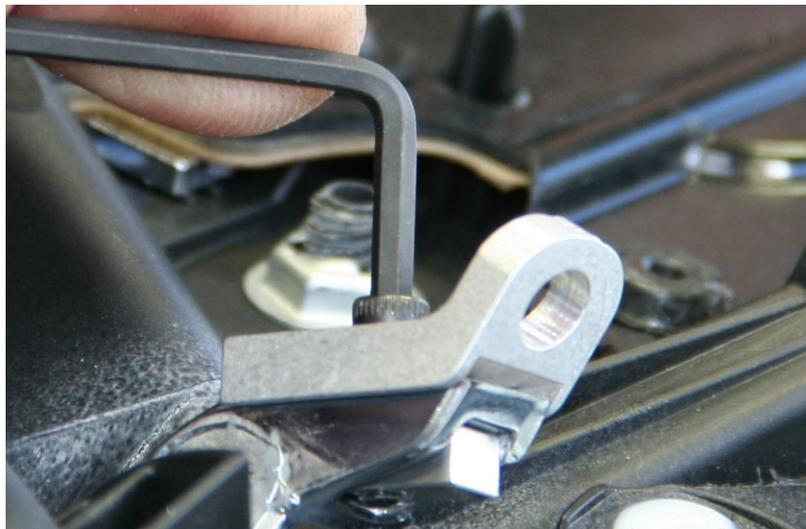
8: Install the aluminum bracket on top of the plastic lever. Install the supplied 8-32" socket cap head screw with the provided 7/64" Allen wrench and tighten bolt.

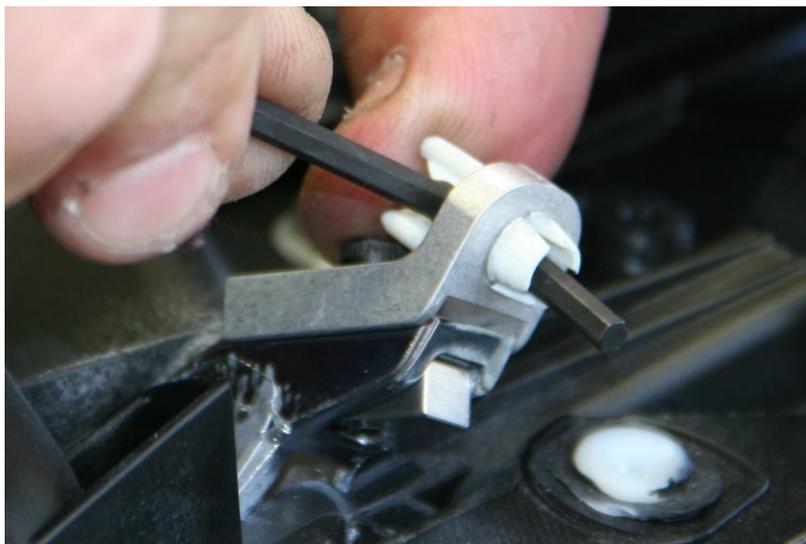
9: Install the new OEM Mercedes clip that is supplied. If needed us the 7/64" allen wrench for leverage as shown in picture. Then reinstall the door panel.
